Savina Technical Service Bulletin # 9

Re: Replacement of Spirolog sensor cable harness

Date: May 12, 2003

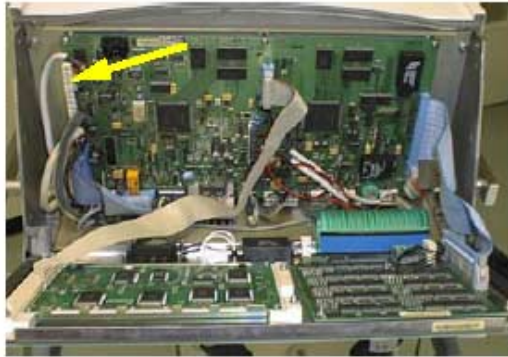
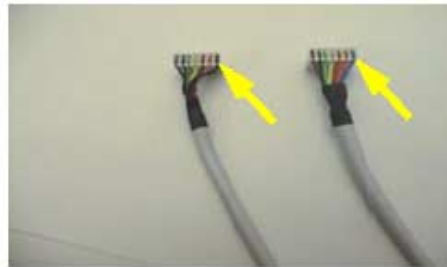
Fig.3: Spirolog sensor cable harness

Cable color on pin 1:

black = version 01

blue = version 02

3. If the cable harness has version 01, replace it with a version 02 cable harness.

Ordering Info: Spirolog sensor cable harness - P/N 8414028
